Edmund Simons*

‘AN EXCEEDINGLY CURIOUS ROCK, INHABITED BY A CLEAN AND DECENT FAMILY’: UNDERSTANDING ROCK-CUT STRUCTURES IN QUARRIED LANDSCAPES

Keywords: rock-cut buildings, quarried landscape, English Midlands

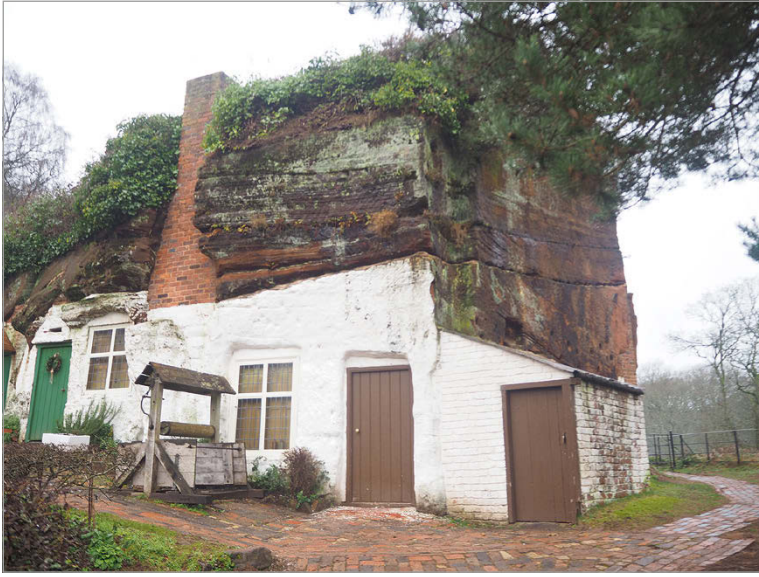
fig. 4. Holy Austin Rock Lower Terracef.

The site lies on three levels, the lower of which contains three houses which were in occupation well into the 20th century and have been refurbished based on old photographs, paintings and illustrations (fig. 3 and fig. 4). At the centre lies a large (once subdivided) space which exploits natural fissures in the rock and is amongst the deepest of the rock-houses locally. The houses on the lower level are all set into tall quarried faces.

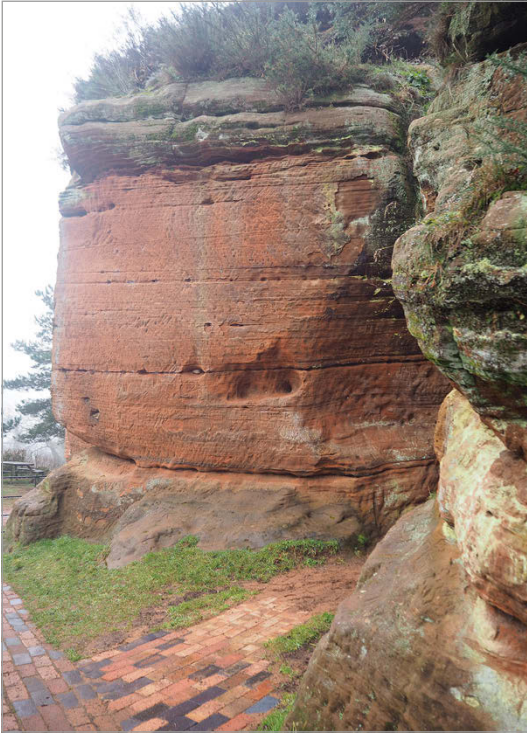
fig. 5. Holy Austin Rock quarrying showing remnants of quarried way building (lower left on photograph).

has ben left, presumably to support quarrying around a natural cleft in the rock. Also, an earlier rock-house survives which has been almost entirely cut way and is visible now only in plan, but retains the remnants of a cupboard and a door channel on one jamb (fig. 5).

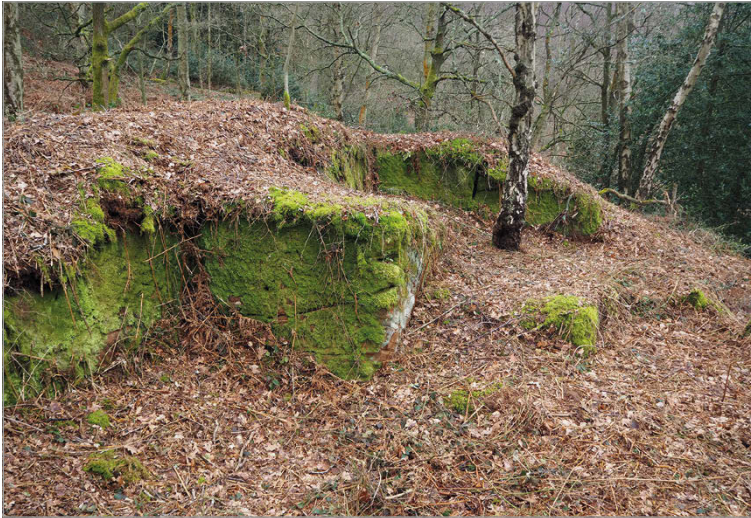
fig. 9. Quarry near Nanny's Rock.

To the immediate west of the site, below the rock, lie a number of quarries, including a quarried roadway, a well, quarried building bases and quarried outcrops. These are largely covered by greenery and although tooling is visible, they remain very difficult to date (fig. 9).

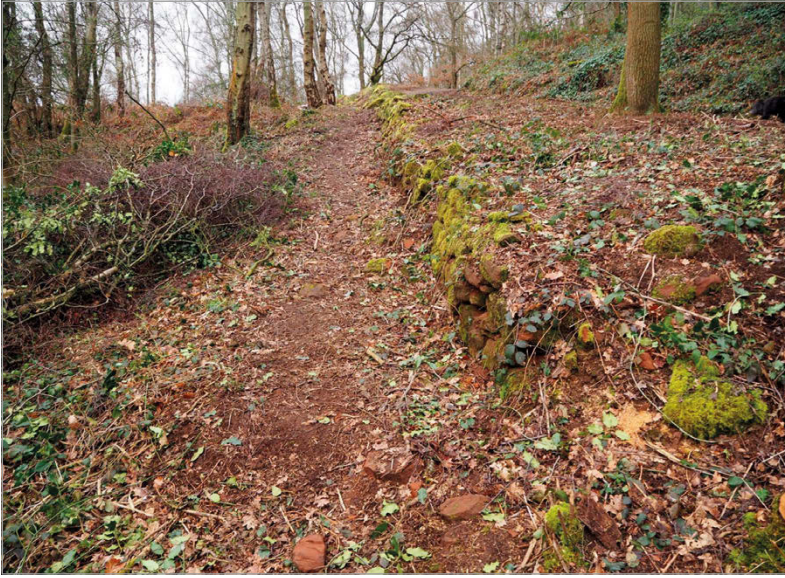
fig. 10. Part of the extensive terracing at Nanny's Rock.

These may all be found in abundance at Nanny's Rock and are being mapped by the author and the National Trust (2023). At the immediate base of the rock-cut building is a terrace and causeway revetted with drystone walls which runs for some 3km along the base of the Edge from north to south. Where it crosses hollows or runs parallel with steep slopes it is a causeway with walls up to c 3m in height. It is associated with a dense network of roadways and field systems which may be found all over the Edge, but are particularly associated with rock-cut buildings.
